INSPECTION REPORT

RCRA Subtitle C

**SMITHSONIAN INSTITUTION AIR & SPACE MUSEUM**  
**UDVAR-HAZY CENTER**

December 3, 2008

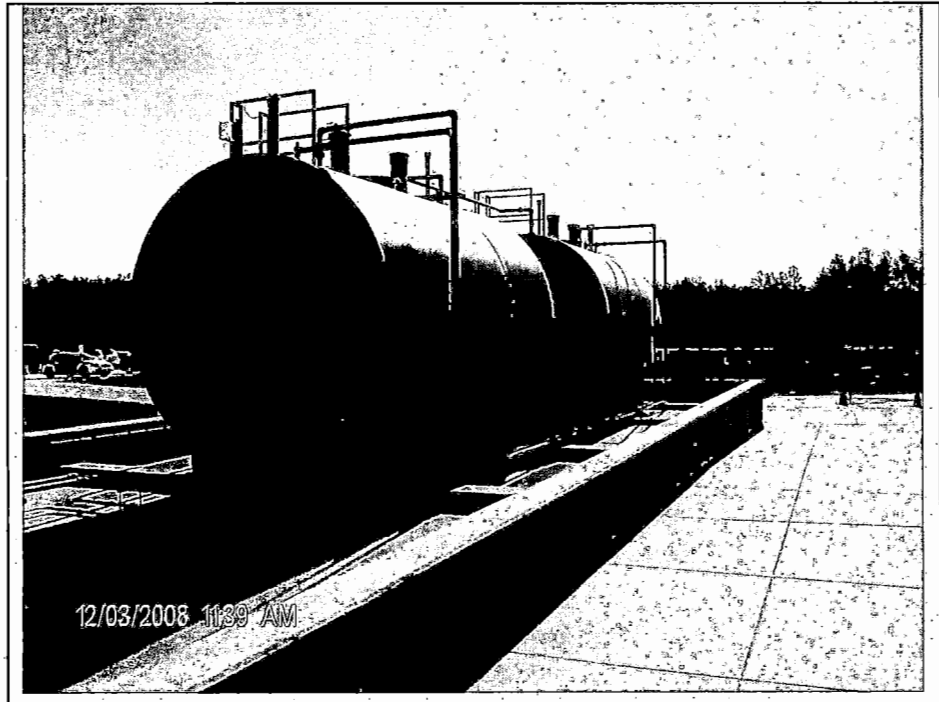
**PHOTO #:** 3

**COMMENTS:** Two 10,000-gallon  
diesel fuel tanks.
